RE: NCWT concerns

I walked the NCWT in Balcones during the rain last Friday and noticed some issues:

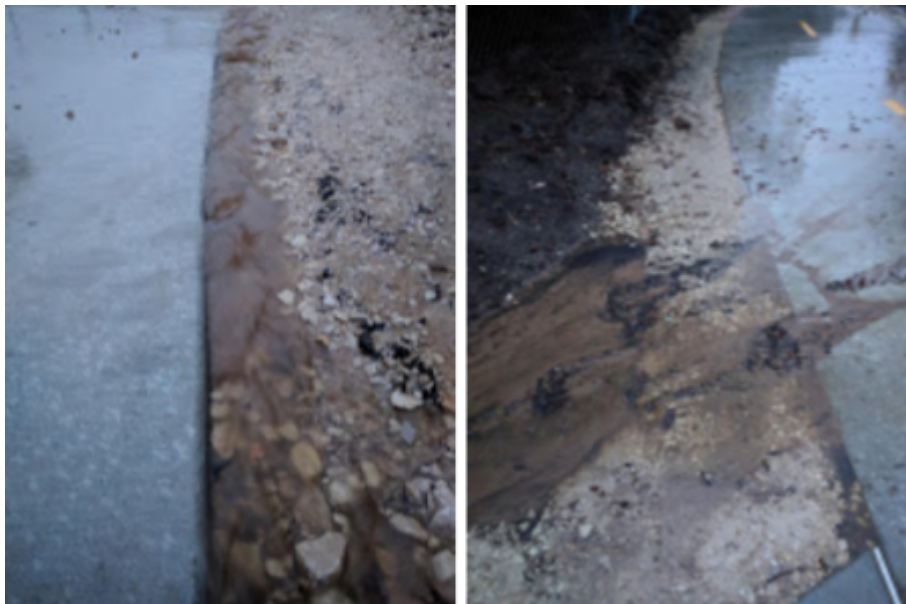
Segments 3-5

-Water flowing down Scribe is jumping out of the street gutter at the new curb cut and flowing down the sidewalk causing considerable rilling along the trail

-the road base that would supposedly "wear like iron" is already eroding in several areas. I continue to maintain that a clay-based organic soil, with Erosion control blanket will be superior in long term erosion control once vegetation is established.

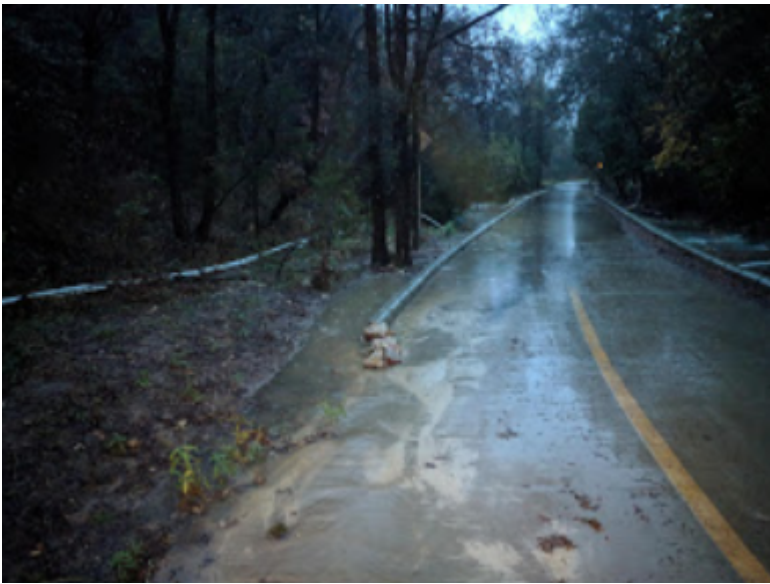
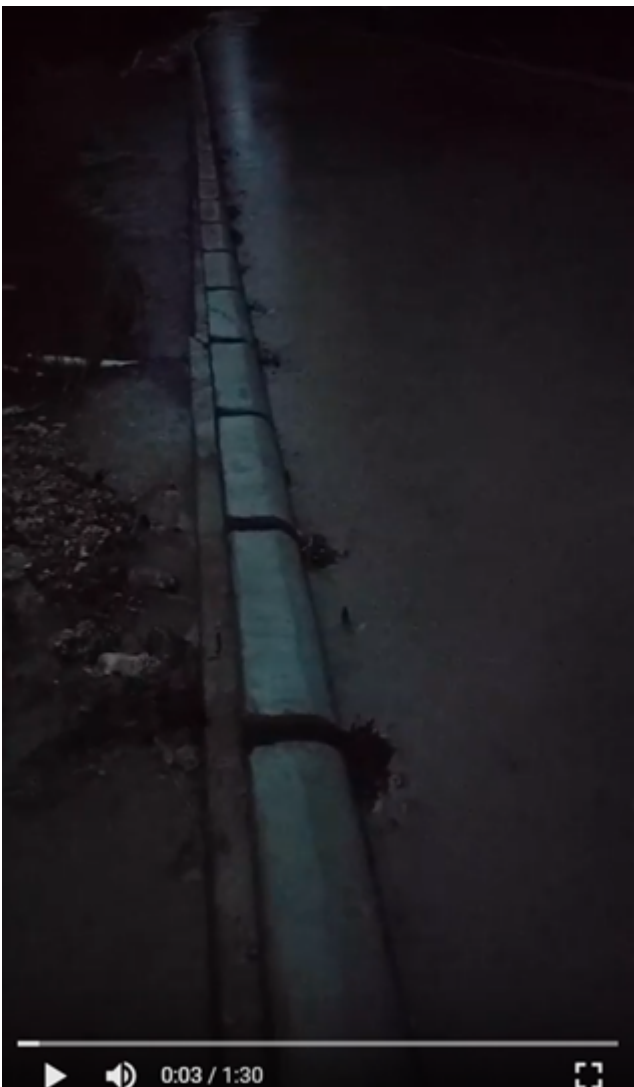
Segment 1-2 (that was never properly restored)

- water was ponding on the bridge deck due to clogging of the drainage slots - these need to be saw cut wider to prevent clogging. The left hand side of the trail approaching the culvert should be reshaped to allow drainage to get to the creek. Volunteers removed all the accumulated soil from the deck on Nov. 3rd, but it has returned due to soil washing from the unrestored trail side area.

observe that no water is flowing through the cuts, once I cleared a couple of these leaf jams, the deck started draining.
