DATE: 8/28/2019

TO: City of Austin Public Works

RE: Contractor non-performance regarding Tree Planting requirements - Segments 1-2 (CIP 3168.039; 5261.004) Scribe Ballfields to Mopac (project combined with Waters Park Relief Main Interceptor)

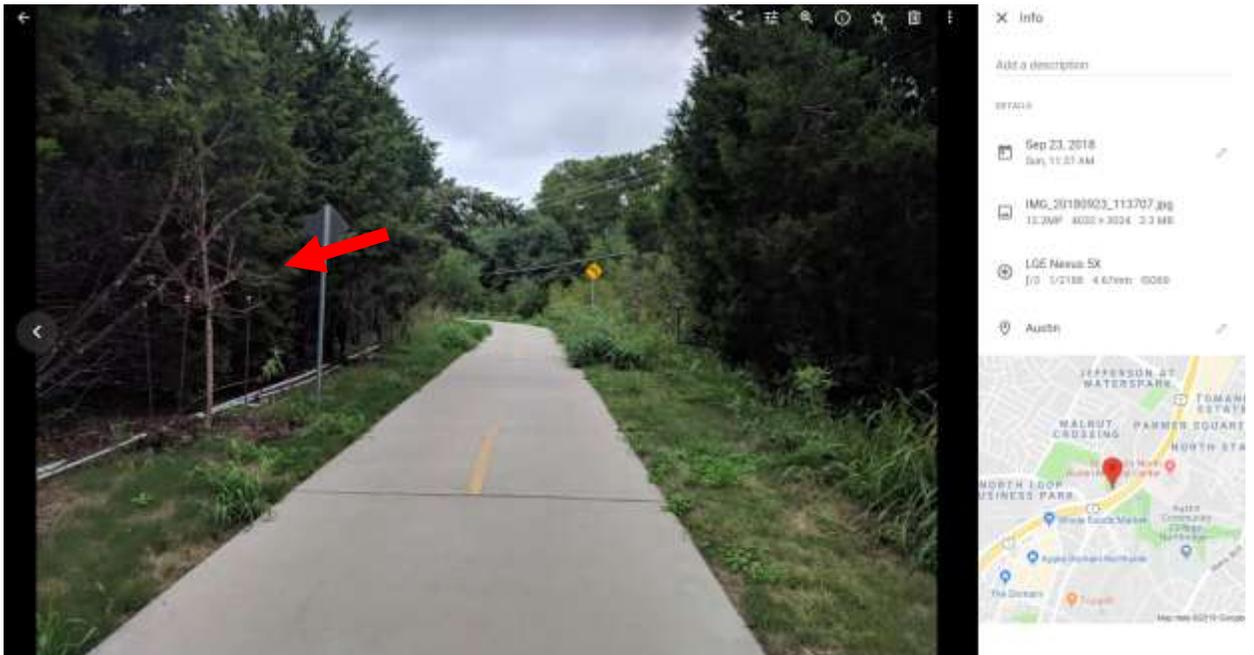
9/23/2018 Photo of dead Burr oak

"ISSUE # 1 Dead trees have not been replaced - trees died due to failure of contractor to ensure adequate watering. This issue was identified Aug 28, 2018 and has not been resolved.

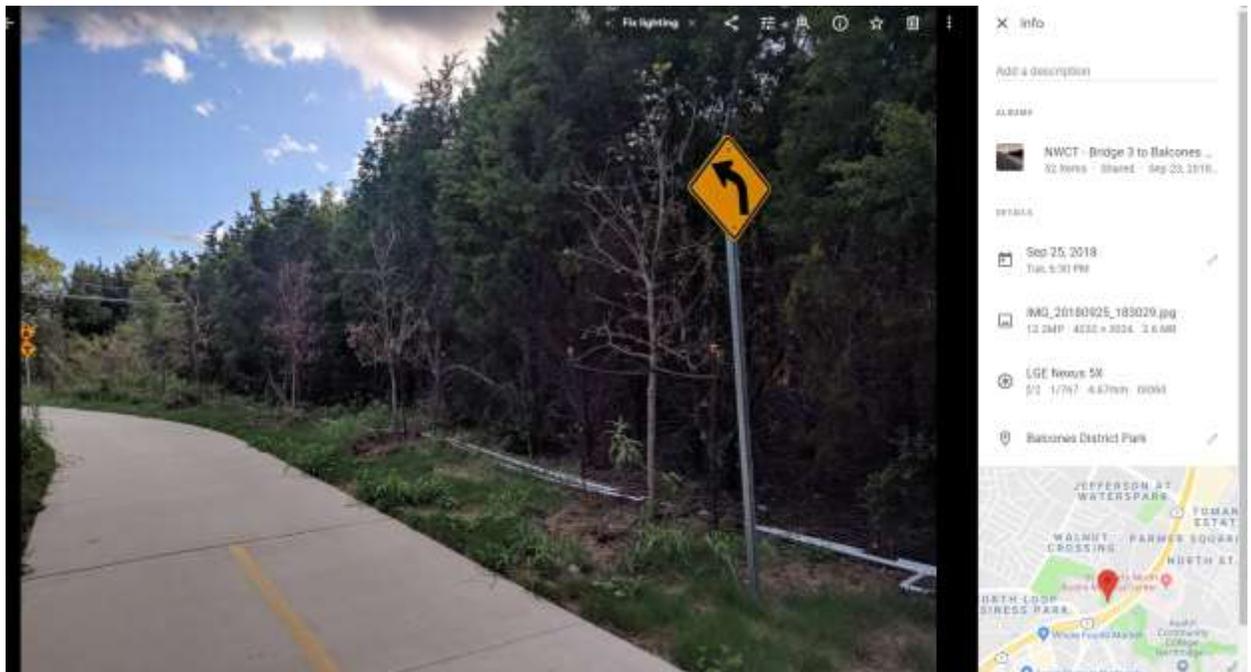
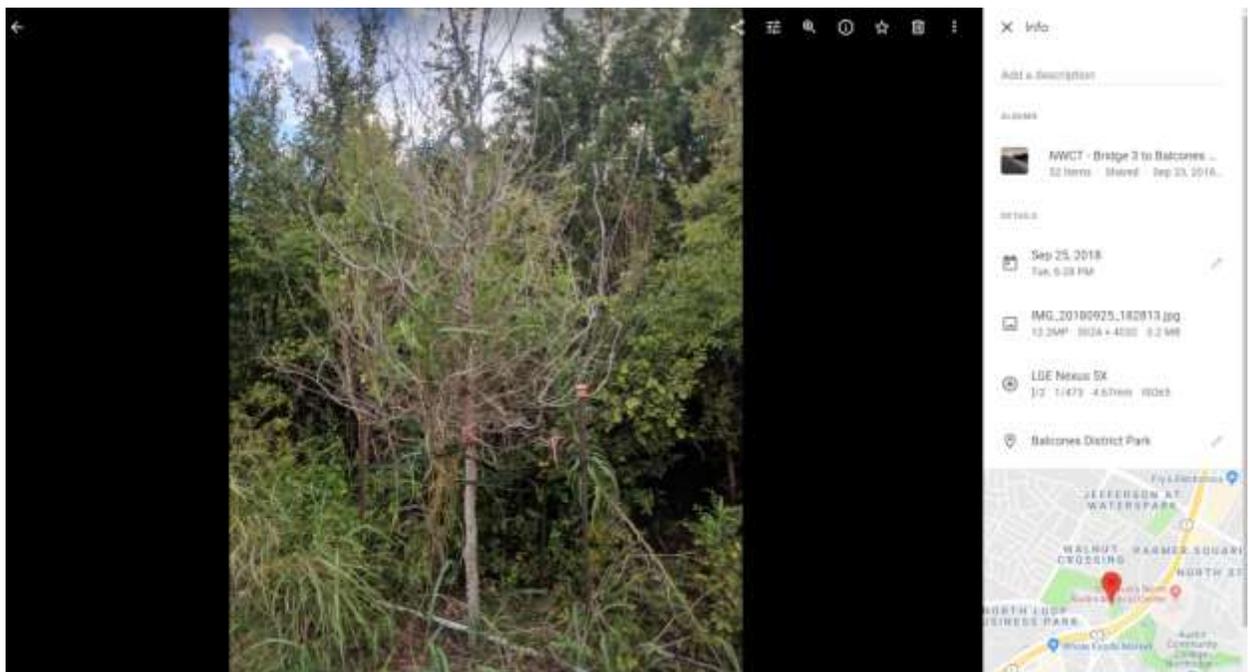
9/25/2018 Photos of dead trees

10/1/2018 Met Larry Mendez at site, looked at erosion and suggested using Erosion Control Blanket, Rip rap or articulated mats (Armorflex, flexamat). We looked at the trees, almost all the Mexican plums were dead and most of the Bur Oaks were dead. Larry advised that he would contact arborist and contractor to replace dead trees.
